HORNBY ISLAND FIRE HALL

OPTION ANALYSIS

Prepared for
Comox Valley Regional District
October, 2008

By
Fletcher Pettis Consultants Ltd

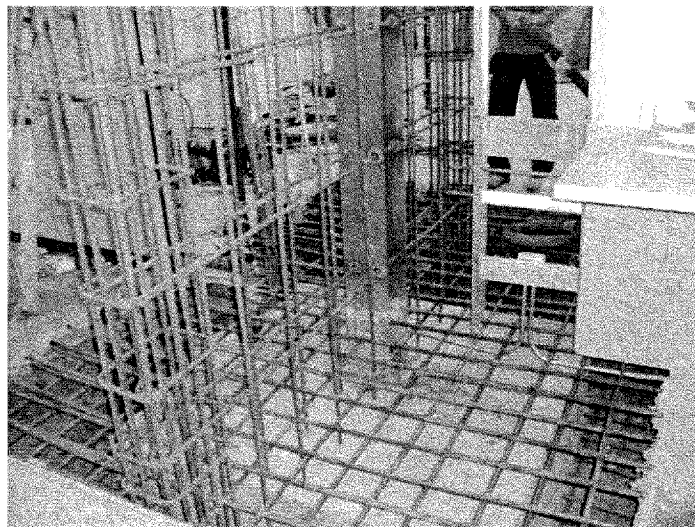
- 1. No vertical or horizontal reinforcing steel in truck bays #1, 2 & 3 masonry shear walls. No grout in the walls.*
- 2. Inadequate foundations for masonry shear walls.*

- 3. Partial height masonry walls in truck bays #3 & #4 with resulting out-of-plane instability.*
- 4. Lack of any shear wall on the southeast elevation. This is a weak storey condition Type 6 irregularity in Table 4.1.8.6.*

Example retrofit with installation of new foundation and steel reinforced shear wall.

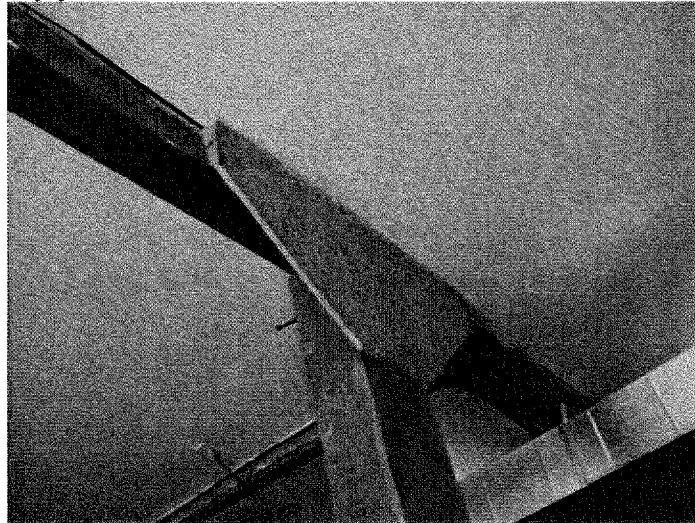
Hornby Fire Hall – inadequate gusset connection of column to beam supporting second floor.

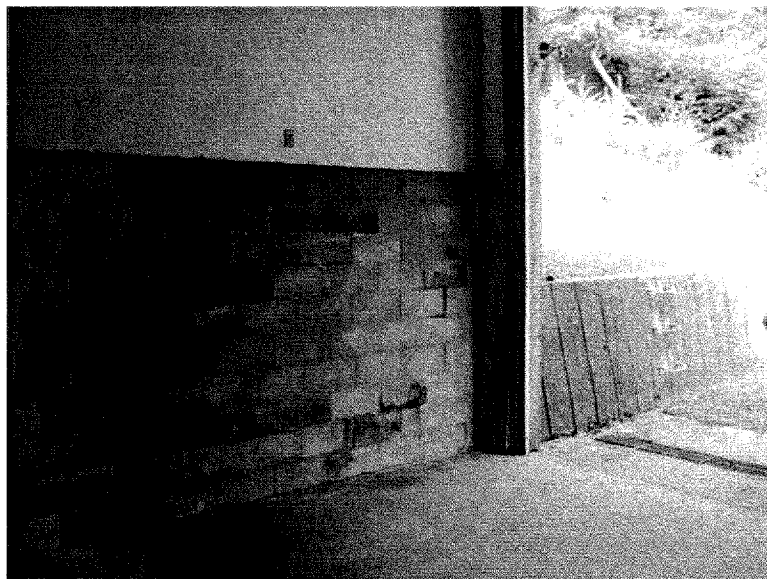
The seismic report recommends that the slope abutting Bay 4 needs to be excavated to keep seismic forces from being transmitted into the structure. New space needs to be constructed to provide for functional deficiencies. As indicated previously, the lot is only about 198 feet wide. The only area for construction is therefore uphill in an area that likely cannot fit the services mentioned above. As well, Fire Department personnel indicate that the needed spaces must be contiguous to the existing hall and at the same level as the remainder of the hall.

Hornby Is Fire Hall – soil to be removed from contact with wall and exterior buttresses to be constructed on exterior side.

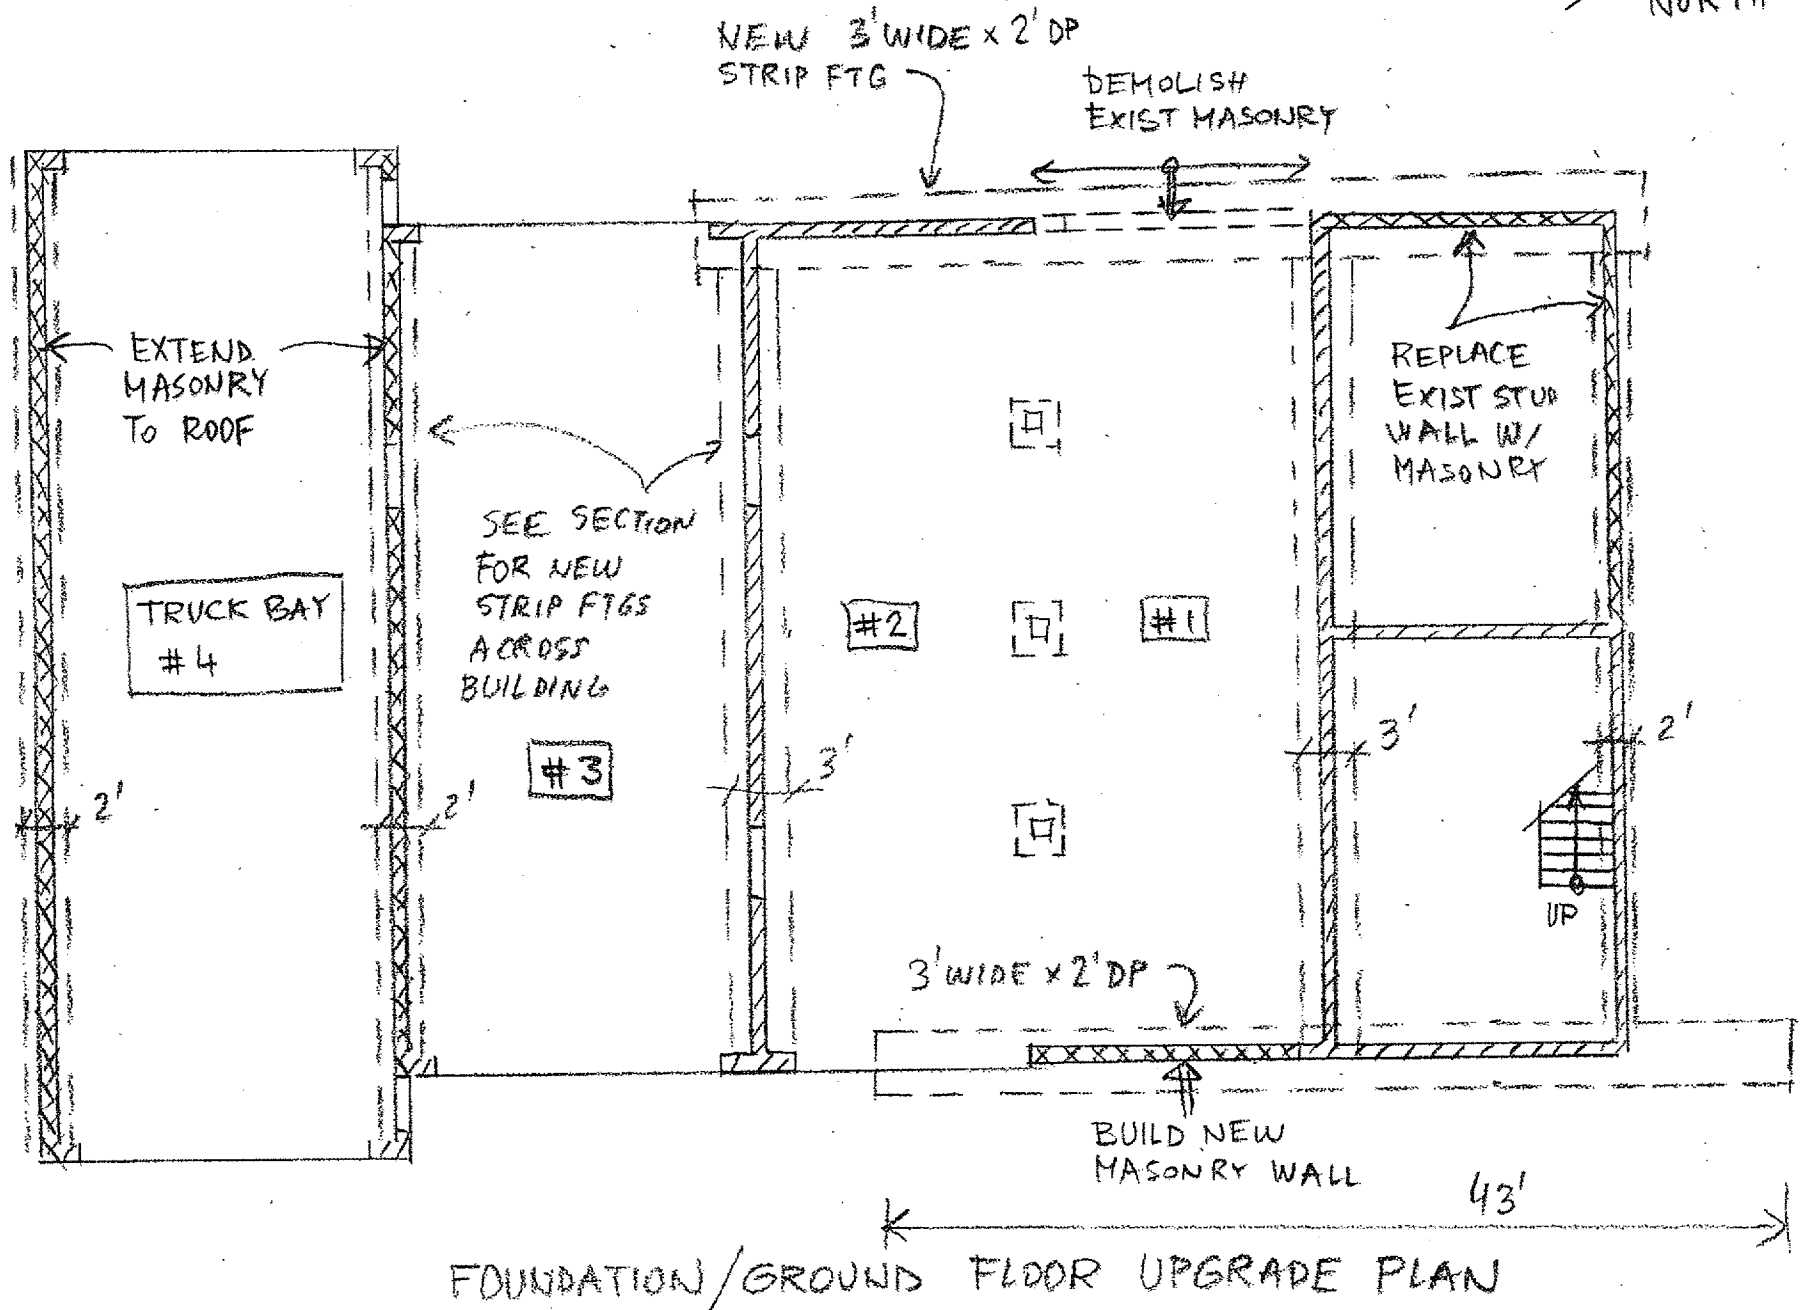
Pomeroy Consulting Engineers Ltd	Hornby Island Fire Hall
Proj No: 08056S	Preliminary Structural Assessment
OPTION 2	Aug, 2008 SK-10

3. Partial height masonry walls in truck bays #3 & #4 with resulting out-of-plane instability.
4. Lack of any shearwall on the southeast elevation. This is a weak storey condition- Type 6 irregularity in Table 4.1.8.6.

3. Construct new foundation and a two storey masonry shearwall on the southeast elevation in front of truck bay #1 and the existing office. See sketch SK-10. The footing is 43ft x 3ft x 24" deep and the wall is 28ft long. These changes require a revision to the overhead door/exit location for truck bay #1 to the northwest end.
