HORNBY ISLAND FIRE HALL

OPTION ANALYSIS

Prepared for
Comox Valley Regional District
October, 2008

By
Fletcher Pettis Consultants Ltd

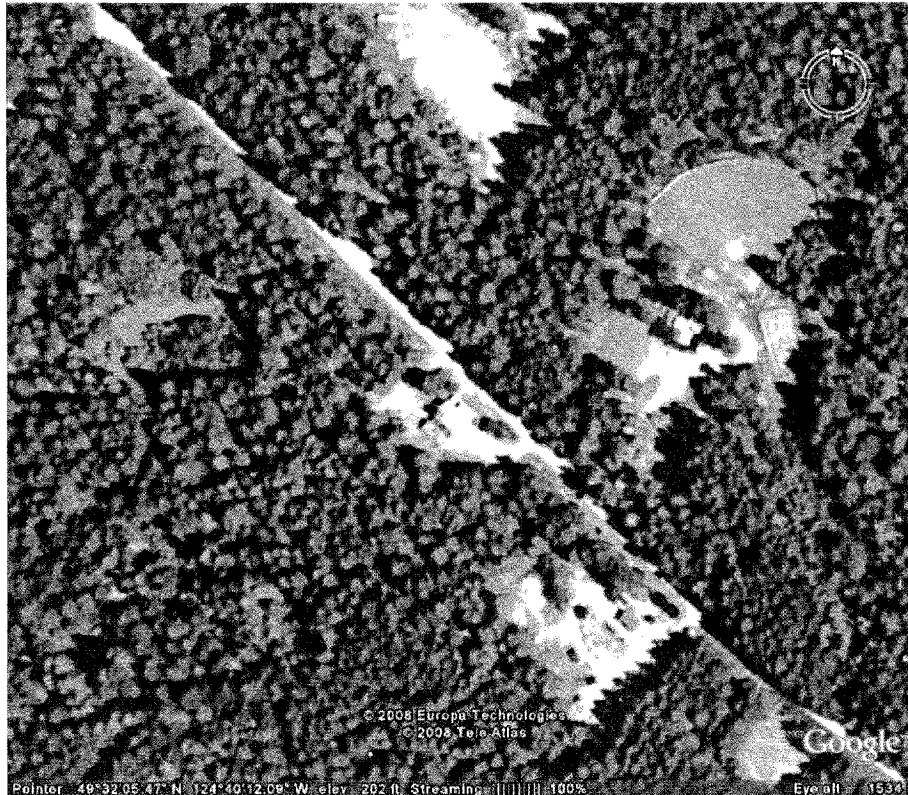
Air photo of Fire Hall and Joe King Park

The following air photo depicts the existing site. The site is partially cleared with the fire hall and access pavements located on the front half of the lot. At the rear of the fire hall is a rock face where the lot rises sharply approximately 12 feet. The lot continues to rise gently and this section of the lot remains un-cleared secondary growth. Main access off Central Road is on the SE side of the lot. The fire hall is configured with drive through bays. On the NW side of the hall the lot line is relatively close to the building such that the access/egress requires encroaching on the adjacent property. Access off Central Road on the NW side is onto adjacent property. This should be reconciled and additional property acquired if the hall is retained.

No survey information was available or obtained for this study therefore lot lines were roughly taken off fencing on adjacent properties and IMap information . The site is approximately 1.12 acres in area with a 198 ft frontage and a 240 ft lot depth. The site must provide for space for a sewage treatment system and disposal field as well as water well. The only vacant space is uphill in the wooded area. The required distance between well and disposal fields is usually a minimum of 50 feet, but it is assumed that to get separation the well would have to go near the front of the lot and downhill from the disposal field. This may be an issue with respect to contamination.

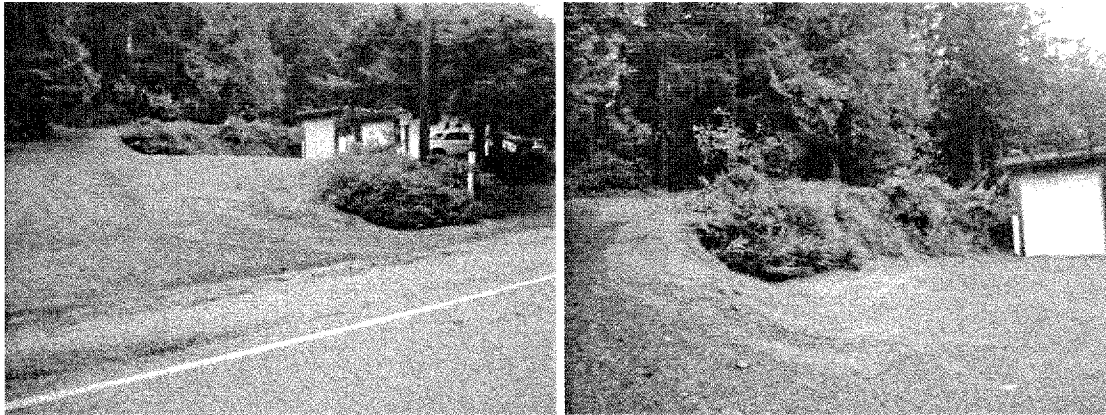
A final issue identified on this site is adequate space for a training area. The training area has been identified as one concrete pad of 40' x 40' and another area of equal dimensions to conduct training for enclosed spaces which would utilize containers. Both areas would be equipped with containment and oil/water separators. The area behind the existing hall is approximately 155' x 198'. Into that area two training pads must be located as well as a septic field and reserve field, the necessary setbacks from property lines and combustible structures as well as roads that would allow vehicle access. The following picture shows how the site is stepped up from Central Road. The grade has been identified as an issue with getting trucks up to the training site.

The seismic report recommends that the slope abutting Bay 4 needs to be excavated to keep seismic forces from being transmitted into the structure. New space needs to be constructed to provide for functional deficiencies. As indicated previously, the lot is only about 198 feet wide. The only area for construction is therefore uphill in an area that likely cannot fit the services mentioned above. As well, Fire Department personnel indicate that the needed spaces must be contiguous to the existing hall and at the same level as the remainder of the hall.
